NIGERIA EROSION AND WATERSHED MANAGEMENT PROJECT (NEWMAP)

ENVIRONMENTAL AND SOCIAL MANAGEMENT PLAN (ESMP) FOR ST LUKE'S HOSPITAL GULLY EROSION SITE, UYO, AKWA IBOM STATE

FINAL REPORT

NOVEMBER, 2017

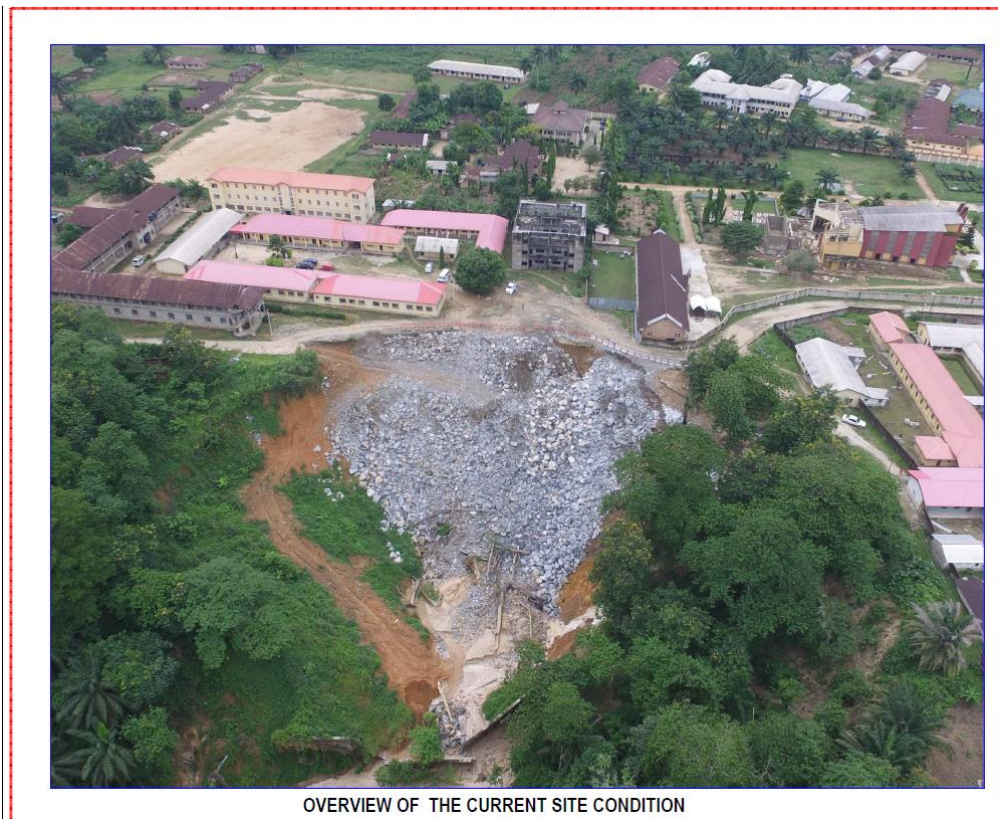
Plate 3.1: St. Luke's hospital, Anua Gully Erosion Area of Influence

A panoramic view of the project's area of influence can be seen in Plates 3.1. The project's area of influence or catchment area covers a large section of Uyo metropolis, especially along the Nwaniba Road and adjoining streets (Plate 3.1). As shown in the photograph, the head-stream of the Anua gully erosion is largely occupied by physical structures but the middle and downstream are covered with vegetation. St. Luke's Hospital and Etim Umana gullies share the same basin downstream (Plate 3.4). The major landmarks found within the catchment area are: The St. Luke's Hospital, The School of Nursing and Midwifery, St. Joseph's Primary School and St. Joseph's Catholic Church. There are numerous residential and business buildings situated away from these four major establishments (Plate 3.1). The erosion has already consumed a large portion of the land belonging to St. Luke's Hospital and the School of Nursing and Midwifery. The St. Joseph's Catholic Church old worship hall at the foreground of Plate 3.1 has not been spared either, as the walls of the building have cracked in many places. Former remedial civil works to arrest the rampaging gully erosion was largely unsuccessful as the underground drainage structures can be seen thrown about the ravine (Plate 3.3).

Uyo metropolis is generally low-lying with no appreciable relief. However, the north-eastern flank of the metropolis could be described as moderately undulating topography due to the presence of dry valleys. St. Luke's Hospital gully erosion site is located in the north-eastern flank of Uyo, and in the rear end of the hospital (Plate. 3.1). The ravine is less than one

St. Luke's Hospital Gully Erosion site is located within Uyo metropolis in Akwa Ibom State. In strict trigonometrical sense, it is found at the intersection between latitude 5.031348North and longitude 7.958886East. The project is located in Offot Clan and occupies the rear end of St. Luke's Hospital east boundary with the School of Nursing and Midwifery (Fig. 3.3 and Plate 3.1).

Also, the respondents expressed their awareness of actual losses sustained by others within the community due to the gully development. Such losses include: properties, farmlands, tree crop, community prized land, and the highly threatened St Luke Hospital gully erosion site. Table 4.9 has statistics on the awareness of types of losses incurred by members of the community based on the perception of the respondents. Most of the identified losses to the ravine include farmland (68.6%), tree crops (34.3%), ancestral/community land (34.3%) and title land/forested land (22.9%). Over 90% of the respondents are concerned about the fate of St Luke Hospital which is at the verge of being consumed by the gully and in particular, the recently renovated Dr. Ward’s Administrative Complex, classrooms and hostels of the School of Nursing and Midwifery, the worship hall of St. Joseph’s Catholic Church and a connecting road between the hospital and the school of nursing and midwifery (Plate 3.1).

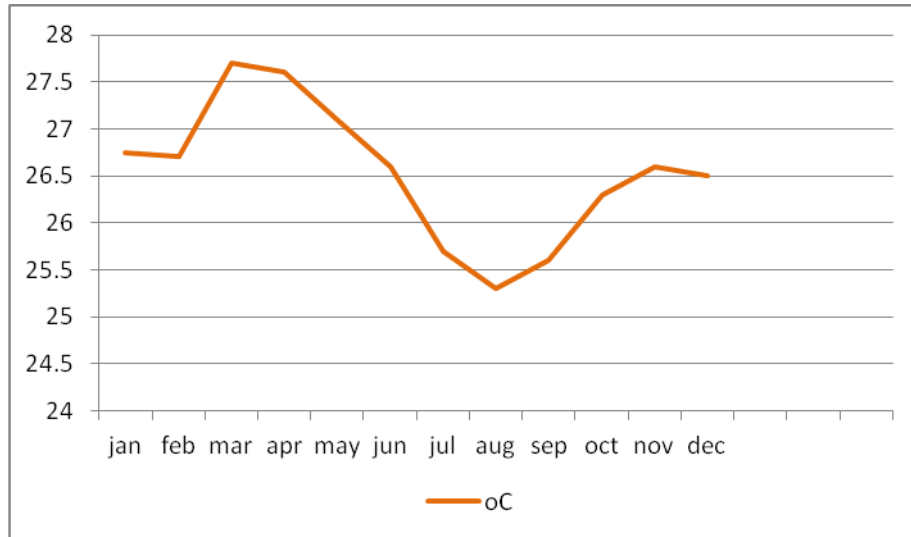
Figure 3.8: Mean monthly minimum temperature values (2000-2009)

It is quite evident in Fig. 3.8 that the mean monthly minimum temperature varies, the highest value of 27.7°C was recorded in the month of March while the least value occurred in August (25.3°C). Generally, low values are associated with the beginning of the year (January and February) as well as in the months of July to September

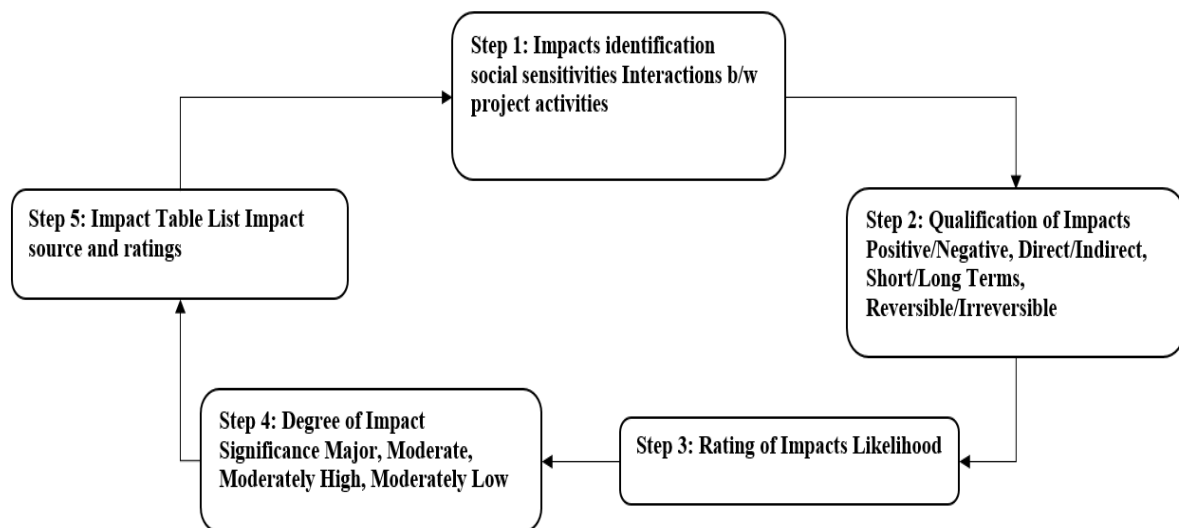
Figure 5.1: Five step tool for impact rating

The identified impacts were classified into four levels of severity:- Low, Medium, High and Extreme, and the Five Step Tool (5ST) impact evaluation model was followed sequentially in order to rate the impacts (Fig. 5.1).

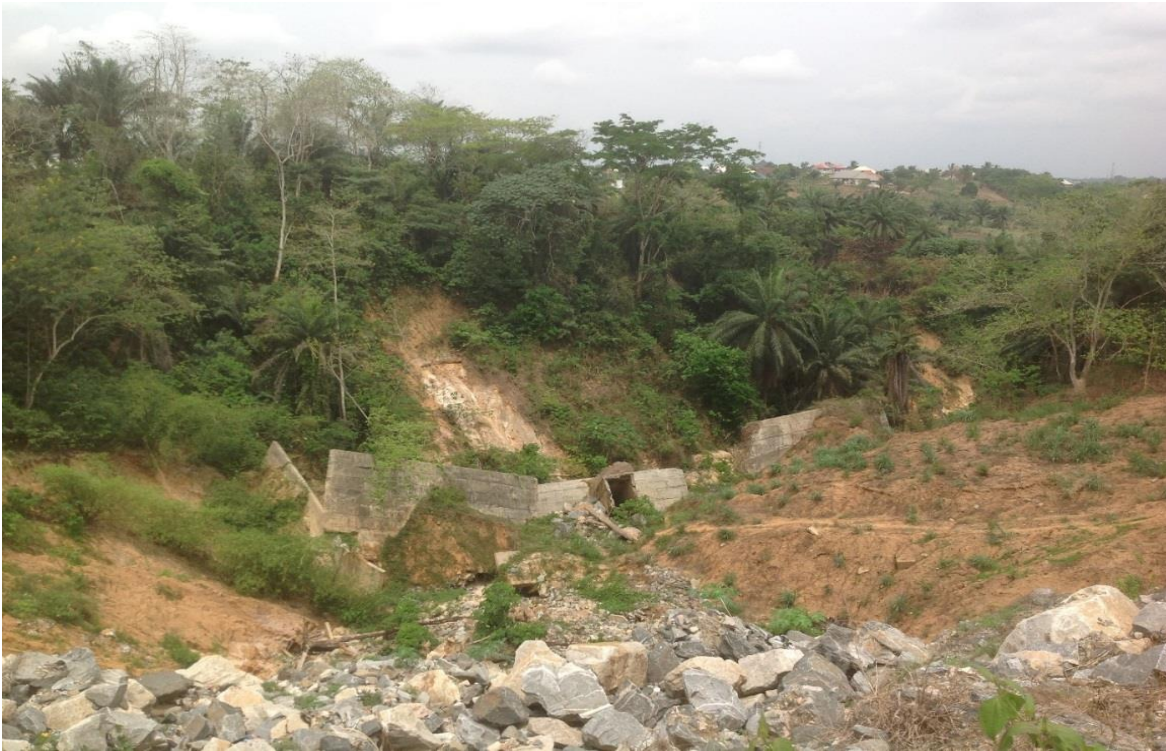
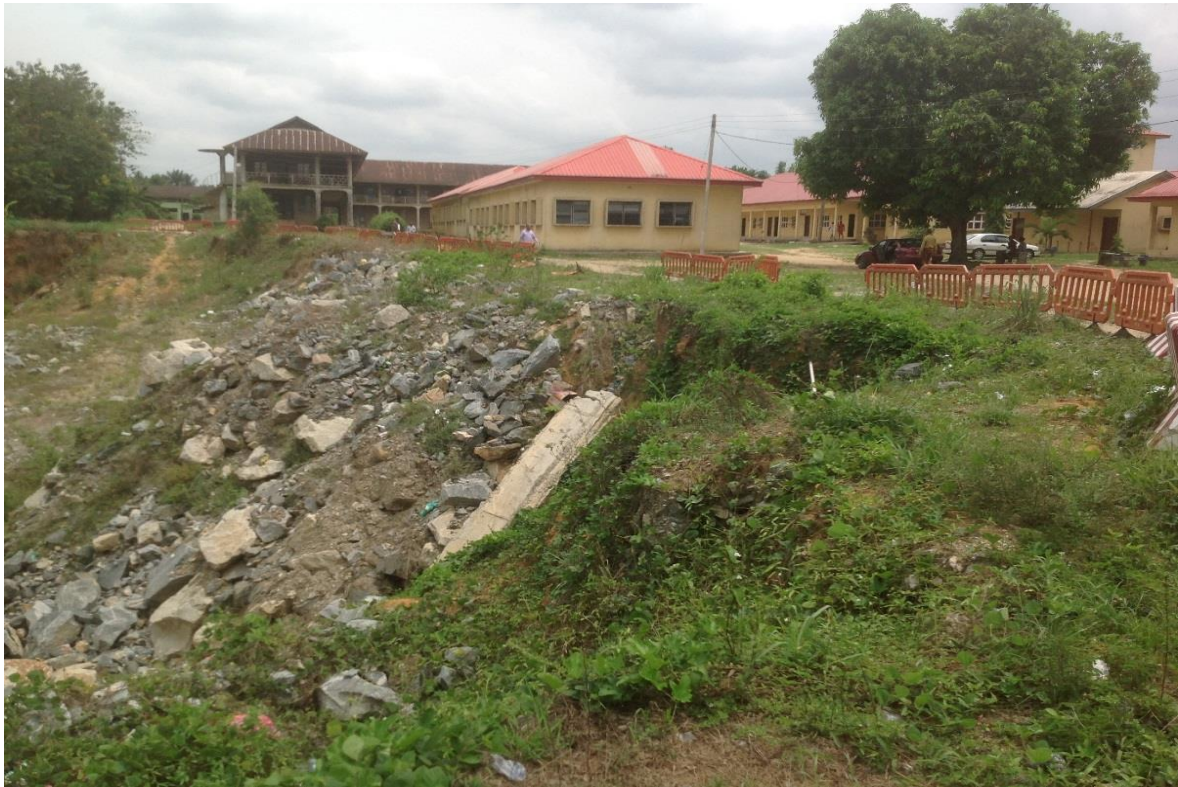
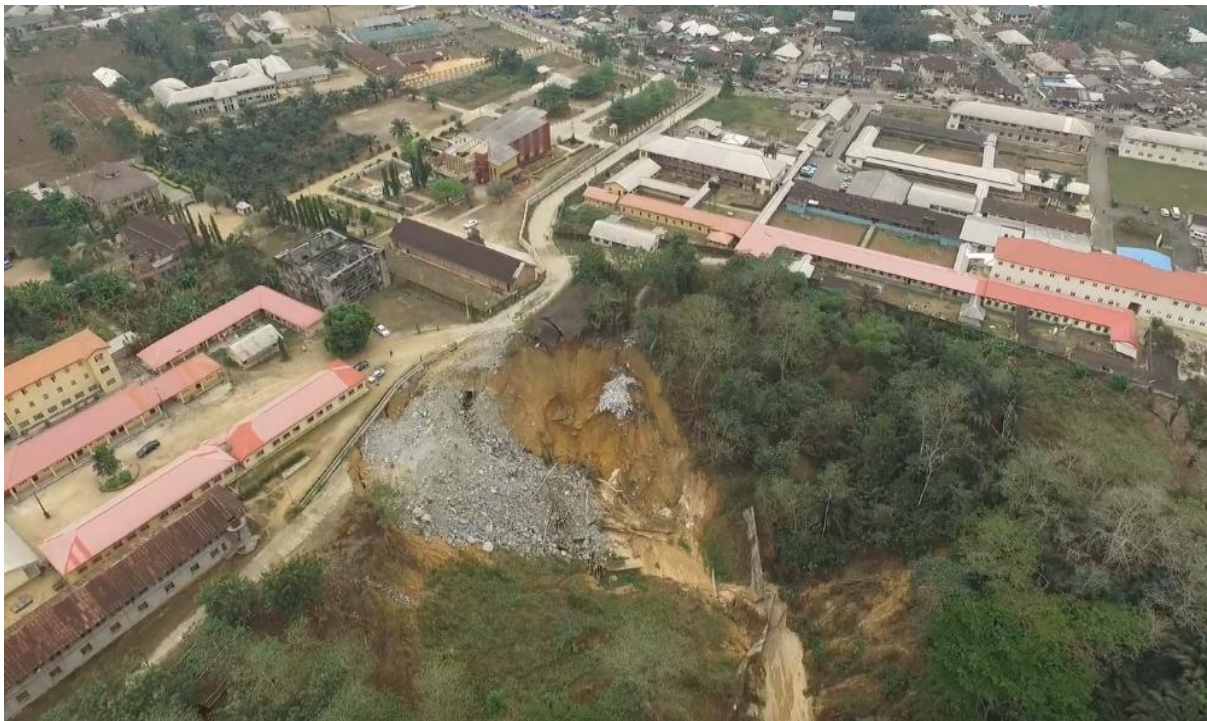
Arial view of the St. Luke's Hospital gully erosion site
